# Case Study of Paint Replacement Applique for Application onto Department Of Defense Shelters and Vehicles 2010

Updated: 2022 February 24

# Appendix A. February 2022 Update

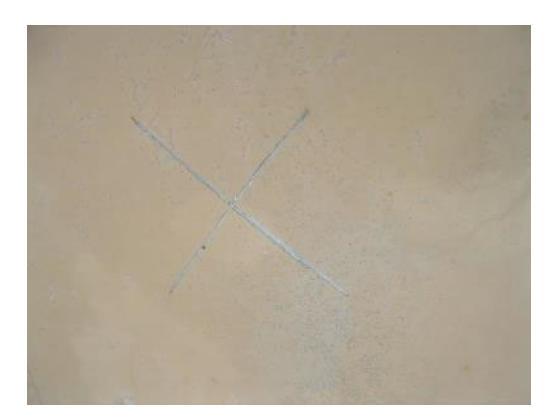
In addition, Integument has worked on a project coating several military land vehicles. Figure 1 illustrates the application of paint replacement appliqué on the USMC's Expeditionary Fighting Vehicle (EFV formerly AAAV). Figure 2 illustrates the effectiveness of Integument's appliqué patch over a pre-scribed area on the EFV after 9 months that includes 300 hours of sea operation and 200 hours of land terrain operation. Not shown are prescribed and damaged areas that illustrate corrosion onset in areas not protected by appliqué.

Figure 2. Appliqué over pre-scribed area on EFV after 9 months including 300 hours of operation in sea and 200 hours of operation on land terrain.

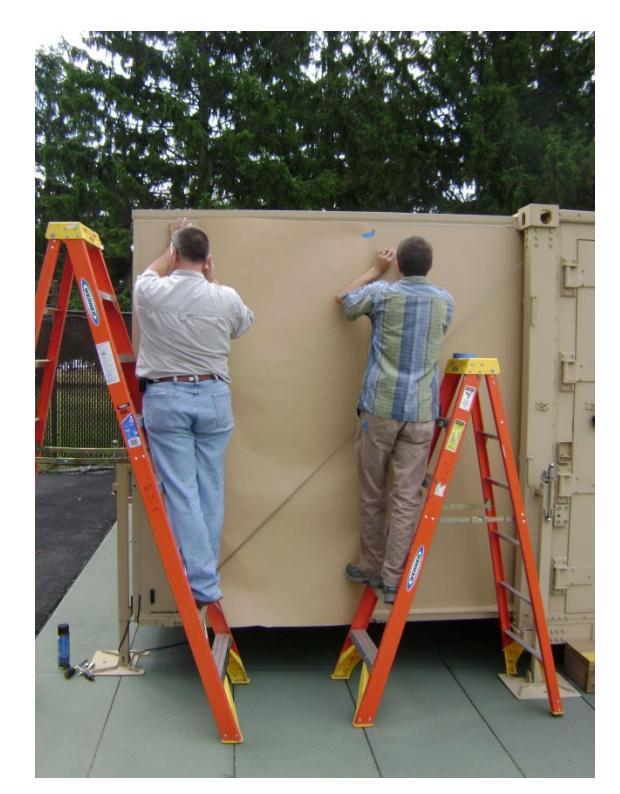
In Figure 11, the cable that could not be removed is seen. Installation had to be performed by slipping the appliqué under the cable that led to some wrinkling problems on the back of shelter

Figure 11. Front panel of shelter - appliqué installation underway.

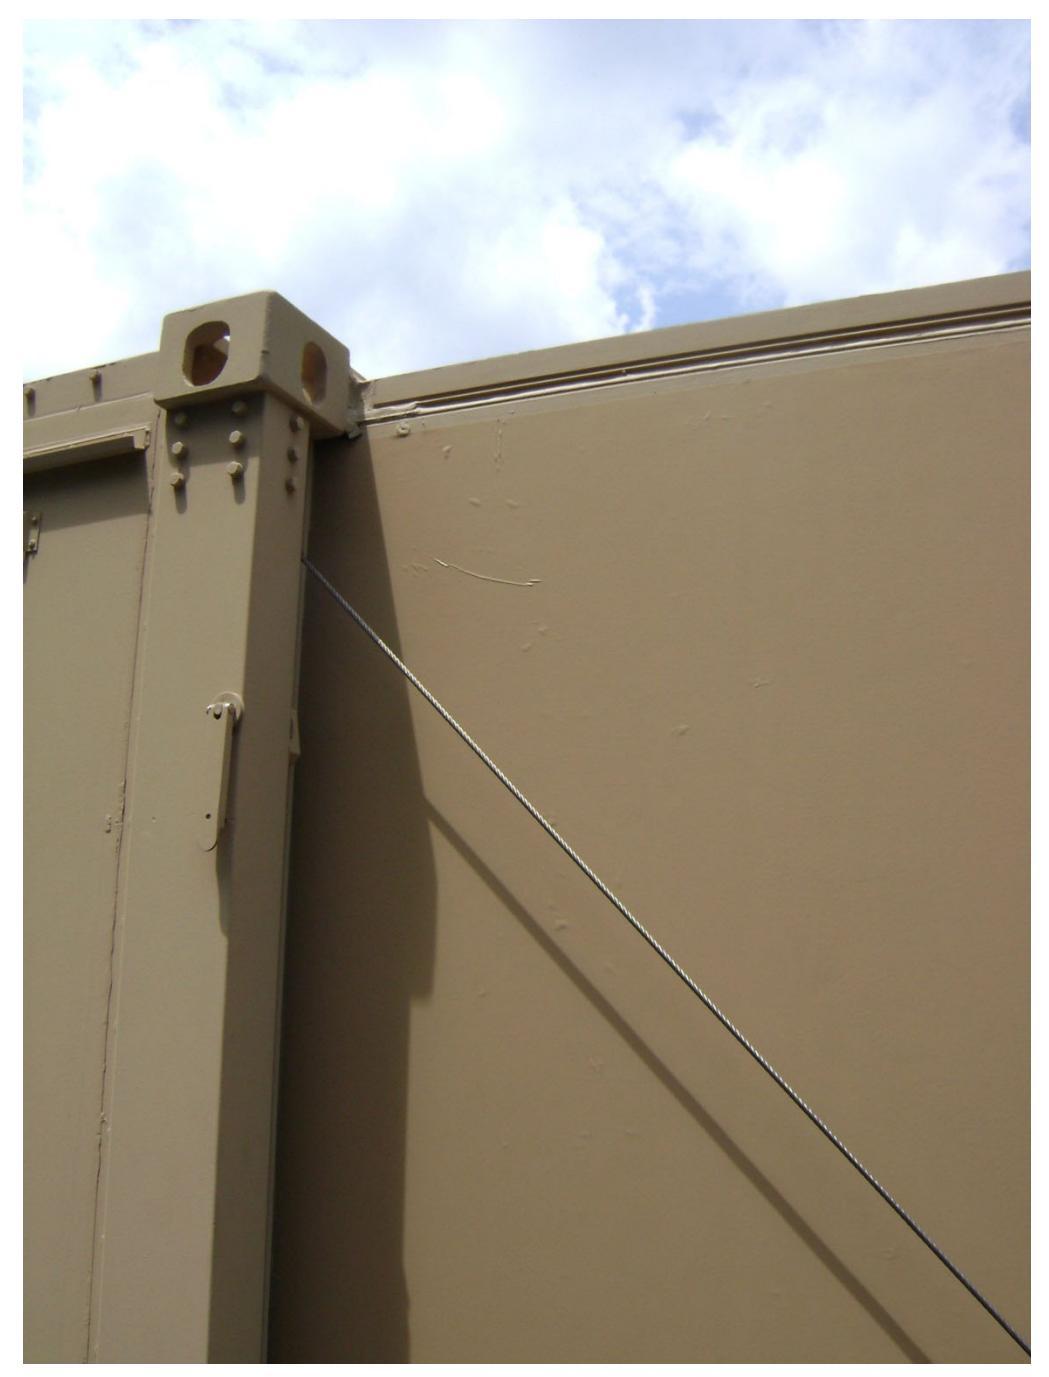
The wrinkling on the back panel (Figure 23) was due to the difficulty in sliding the roll of appliqué under the cable. This was not as apparent on the front section because the installers were able to use their right hands instead of left to apply appliqué to the top corner.

*Figure 23. Defect wrinkling seen at the top left side of coated panel.*

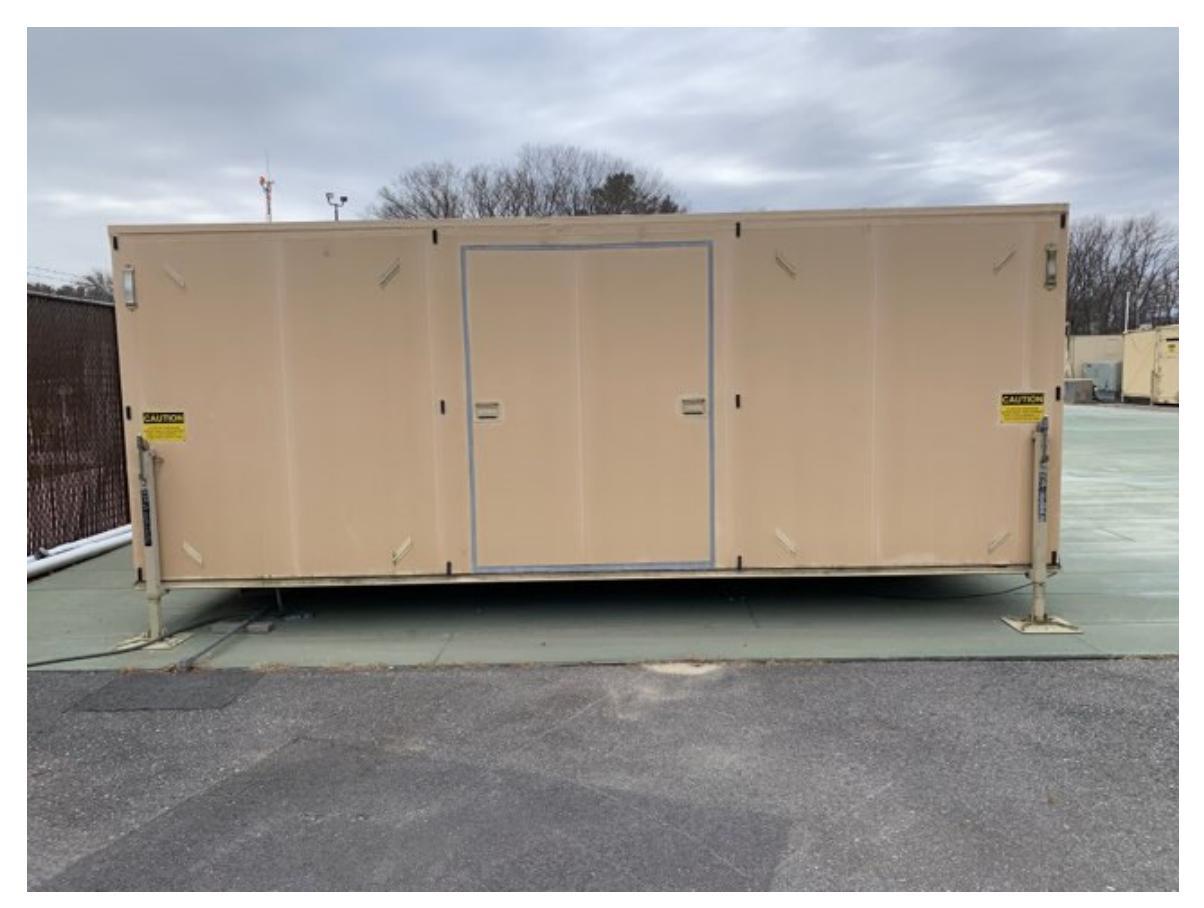
On the whole, FluoroGrip<sup>®</sup> applique has remained intact with no chalking, erosion, cracking, wrinkling, blistering, flaking, or rusting; and in general, excellent adhesion. We note two minor flaws. First, while we do not have quantitative colorimetry data, the seams are now visible – see Figure A-1 below. Second, additional application of a traditional filler-type coating appears to have interfered with the applique, as shown and discussed in Figures A-2 and A-4. These become lessons learned.

*Figure A-1. FluoroGrip<sup>®</sup> applique intact. Seams have become visible over time.*

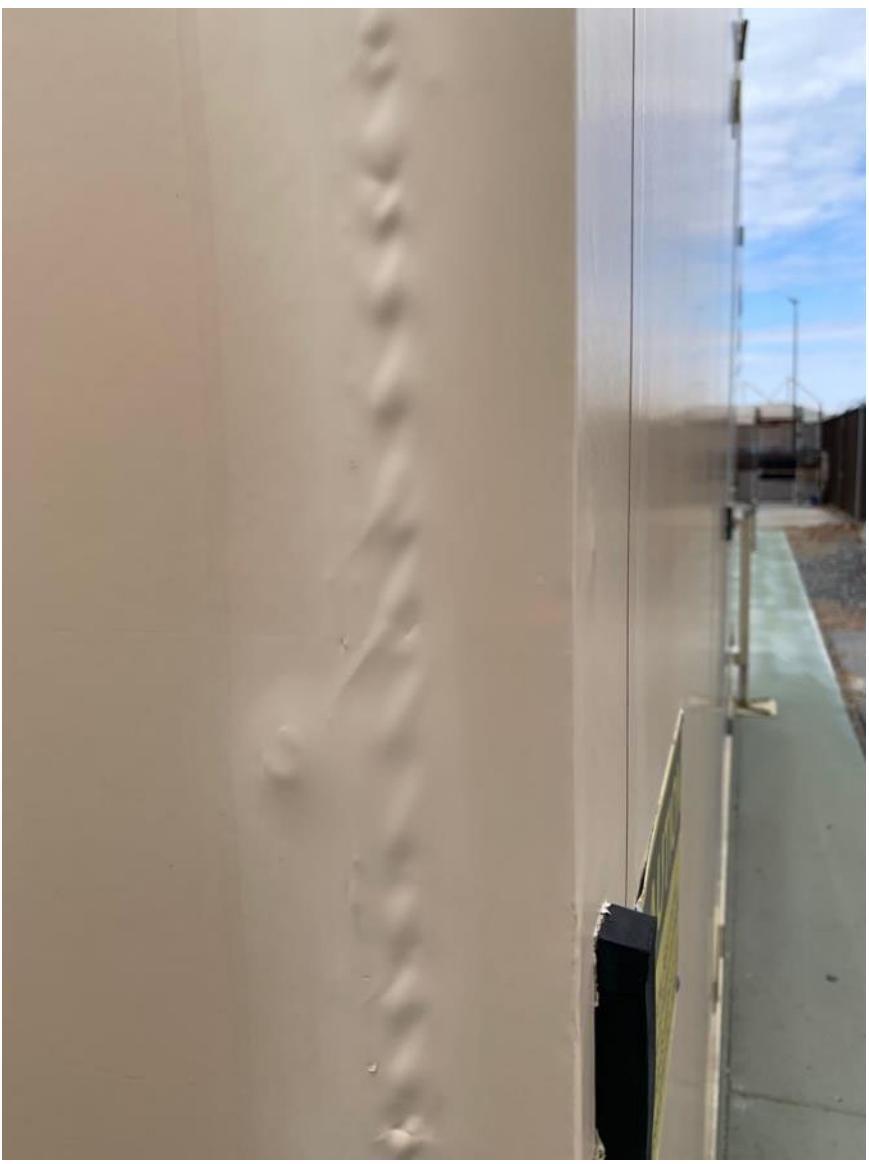
Figure A-2. Pro Seal sealant had been applied some unknown time prior to FluoroGrip<sup>®</sup> installation during other maintenance on a vertical seam. The Pro Seal expands/contracts with the temperature, and lead to a bubbling-like contour along the seam, but the FluoroGrip<sup>®</sup> remains intact.

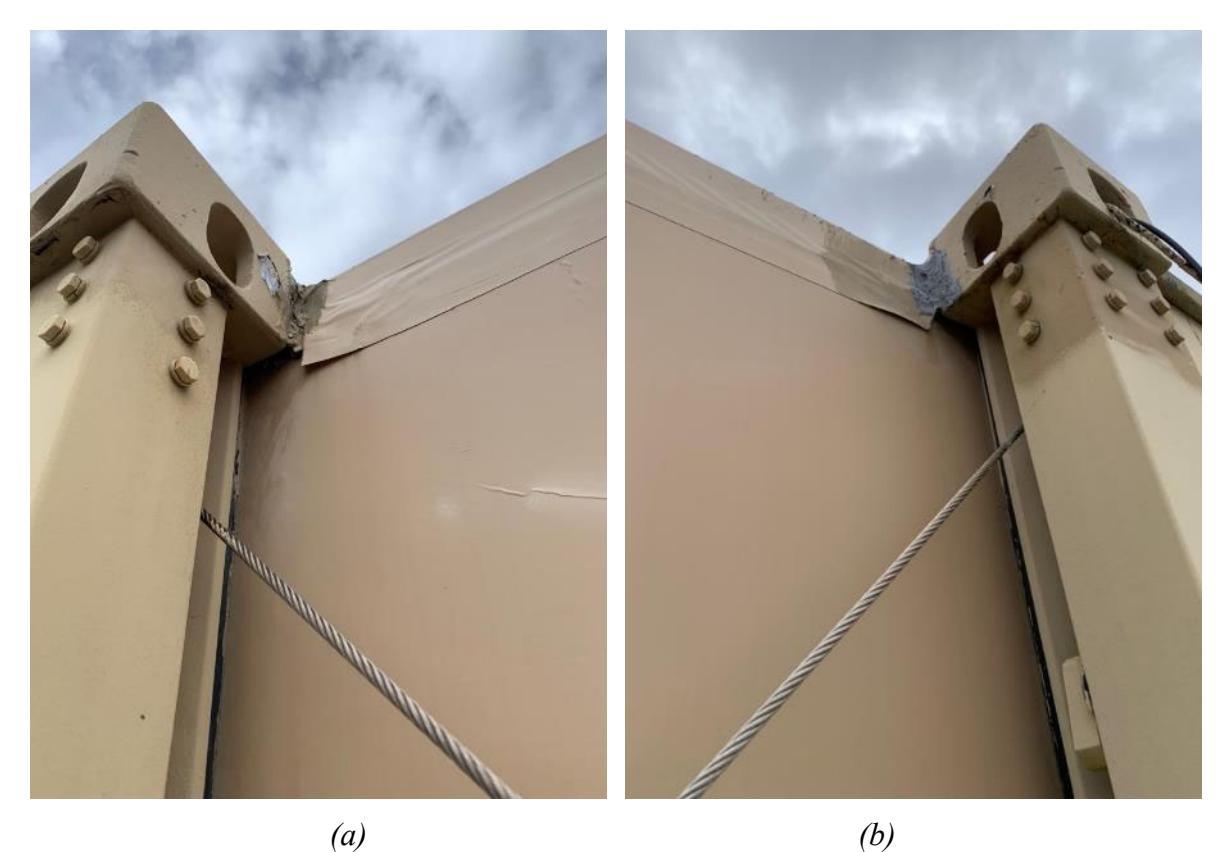
Comparing Figure A-4(a) below with Figure 23 in the main body text: In Figure 23, the roof cap strip was not yet installed, and one can see sealant that had been applied (perhaps during original construction) between the roof and side panel, and more heavily in the area of the vertical bar. At some point in time after the shelter received its paint-replacement FluoroGrip<sup>®</sup> applique treatment, and as seen in Figure A-4, more sealant was applied to the corner area by the vertical bar and the roof line. This other sealant is known to have a relatively large coefficient of thermal expansivity (expands/contracts with hot/cold temperatures). Excess of this sealant underneath the applique may have acted push it off during hotter times, and the overcoat of the sealant may have acted to pull it off during colder times.

*Figure A-4. Roof seam tape has lifted adjacent to the application of another coating.*

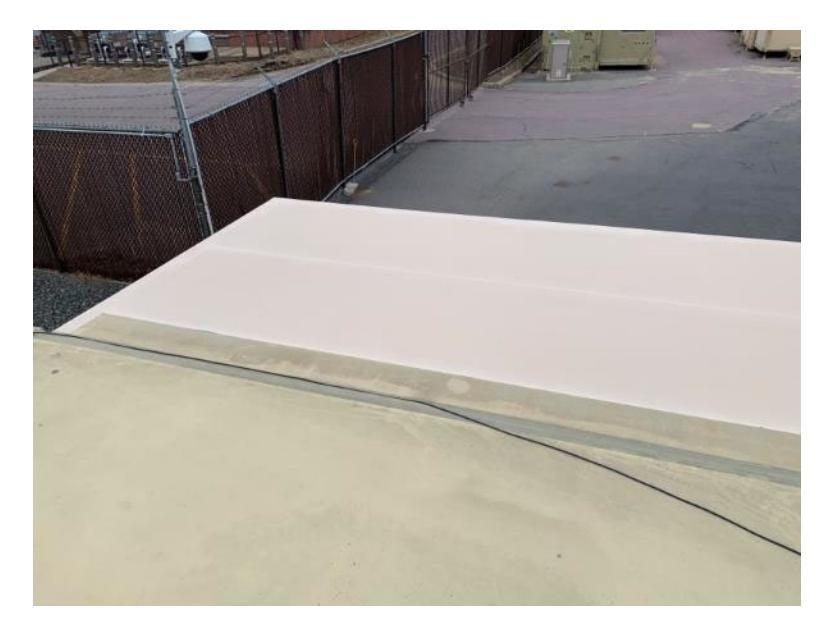
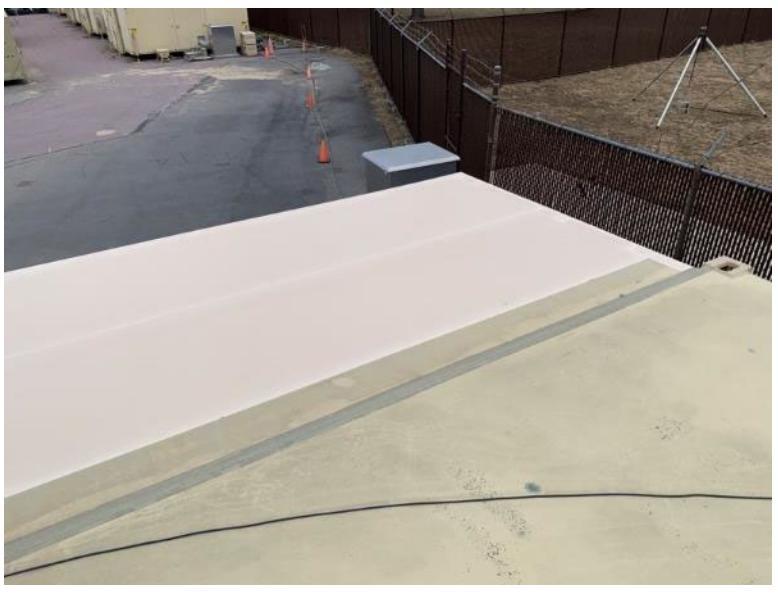
Figure A-5. Applique intact on the roof. The shelter had not been coated with applique over its entire surface.
