HOW TO REPAIR BALLAST TANK COATINGS WITH MINIMAL DOWNTIME

NOVEL SOLUTIONS

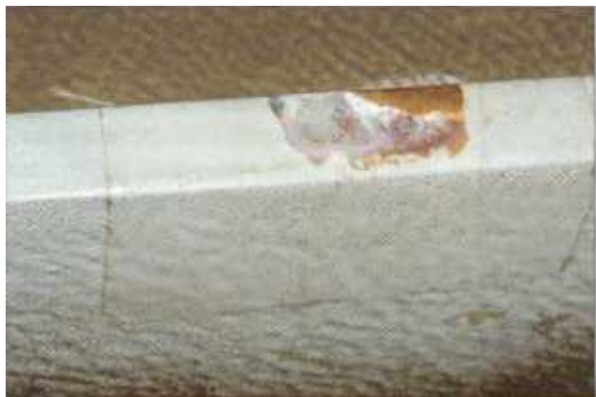
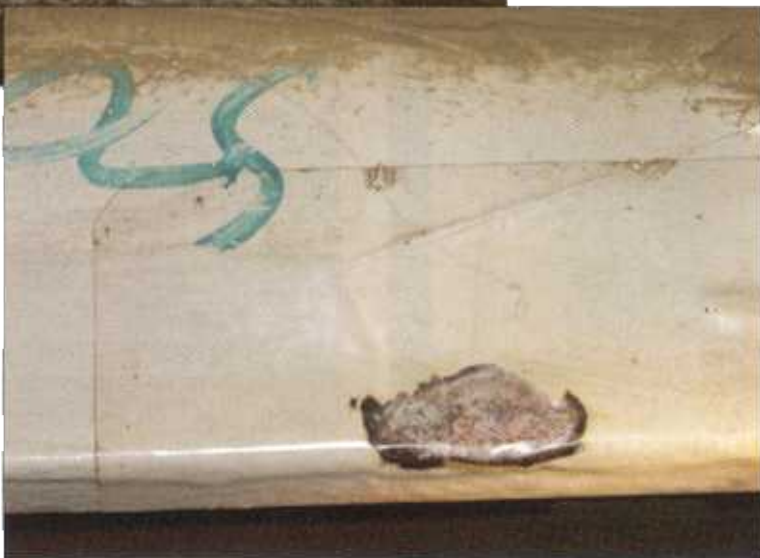
Figures 1 and 2: (at left) show clear fluoropolymer film patches over areas of coating breakdown in a ballast tank of an oil tanker following six months of immersion service. The dark lines in the photos reveal the boundaries of the patches in each picture. Photos courtesy of Integument Technologies, Inc.

Prior to application of the repair film to the oil tanker, surfaces were prepared by hand tool cleaning to remove loosely adhered paint in the repair area. Then the surface area to be

patched was solvent-wiped with alcohol. The manufacturer says the film's adhesive will adhere to paint, to metal, and to concrete as long as the surface is clean, dry, and sound.

About 100 sq ft of the material was applied in the tanker. The manufacturer's employees applied some of the material for the shipper, then instructed the shipper's personnel in applying the remainder. Common hand tools, such as rollers, squeegees, and knives, were used for the application. The corners of the repair film were rounded prior to application.

Repairs on the oil tanker have been in service for 15 months. Figures 1 and 2 show the successful performance of the repair material after 6 months of service.
