# Case Study of Paint Replacement Applique for Application onto Department Of Defense Shelters and Vehicles 2010

Updated: 2022 February 24

# Appendix A. February 2022 Update

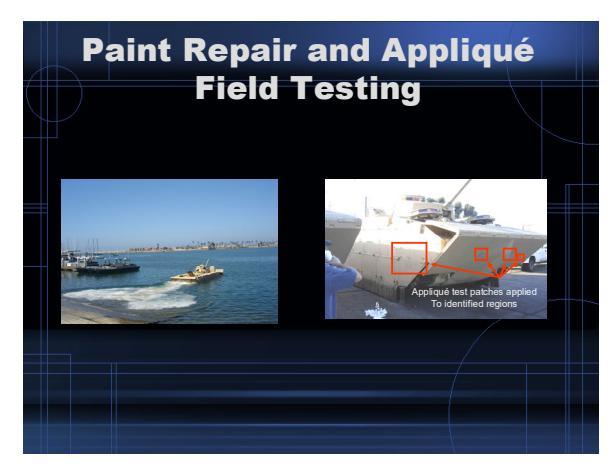
Figure 1. Appliqué Patch application on USMC EFV.

In addition, Integument has worked on a project coating several military land vehicles. Figure 1 illustrates the application of paint replacement appliqué on the USMC's Expeditionary Fighting Vehicle (EFV formerly AAAV). Figure 2 illustrates the effectiveness of Integument's appliqué patch over a pre-scribed area on the EFV after 9 months that includes 300 hours of sea operation and 200 hours of land terrain operation. Not shown are prescribed and damaged areas that illustrate corrosion onset in areas not protected by appliqué.

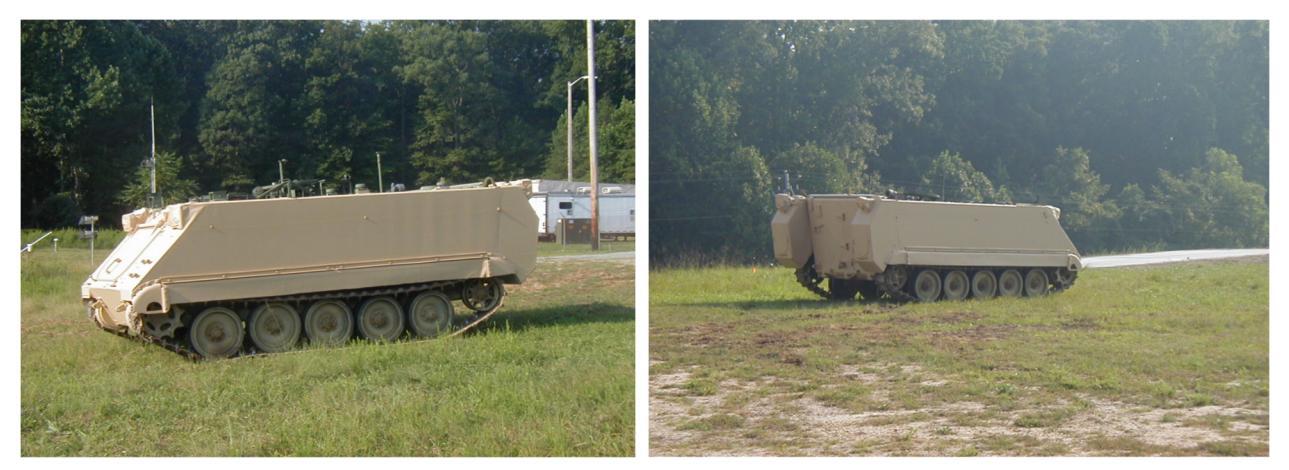
Figure 3. M-113 coated with Mil-color tan appliqué.

Figure 3 illustrates an M-113 coated with Mil-color tan appliqué for a DoD field demonstration. The objective was to demonstrate the ease and quickness of coating and removing appliqué from the vehicle. The vehicle took approximately 1 day to coat and 4 hours to remove, providing the vehicle back to the exact condition it was received.

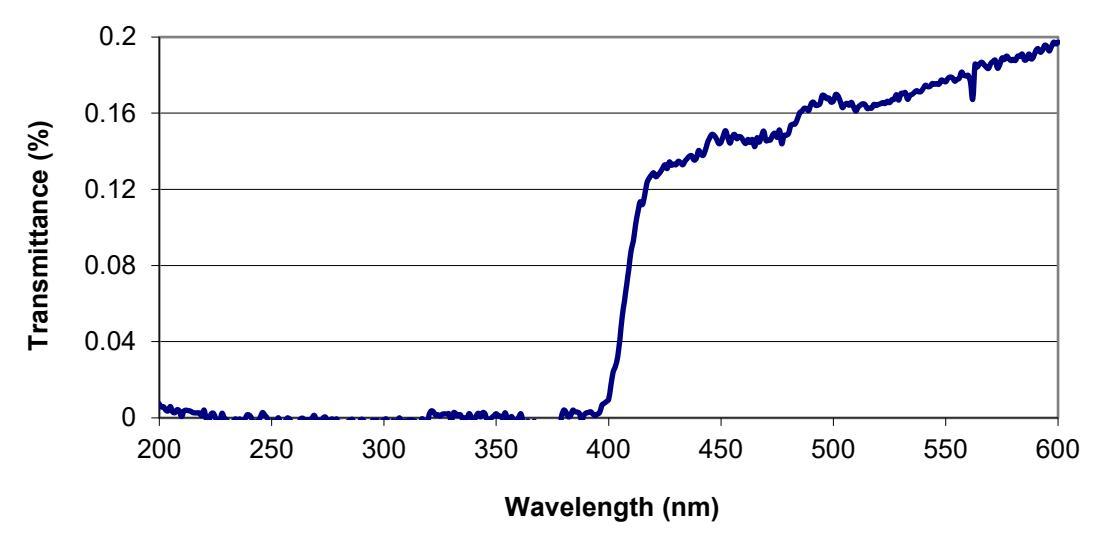
Figure 7. UV-Vis of 3 mil white ECTFE

Figure 7 illustrates the UV spectrum of a white pigmented fluoropolymer appliqué film showing that the applique essentially blocks all UV radiation thereby providing total long term UV protection to any underlying substrate.

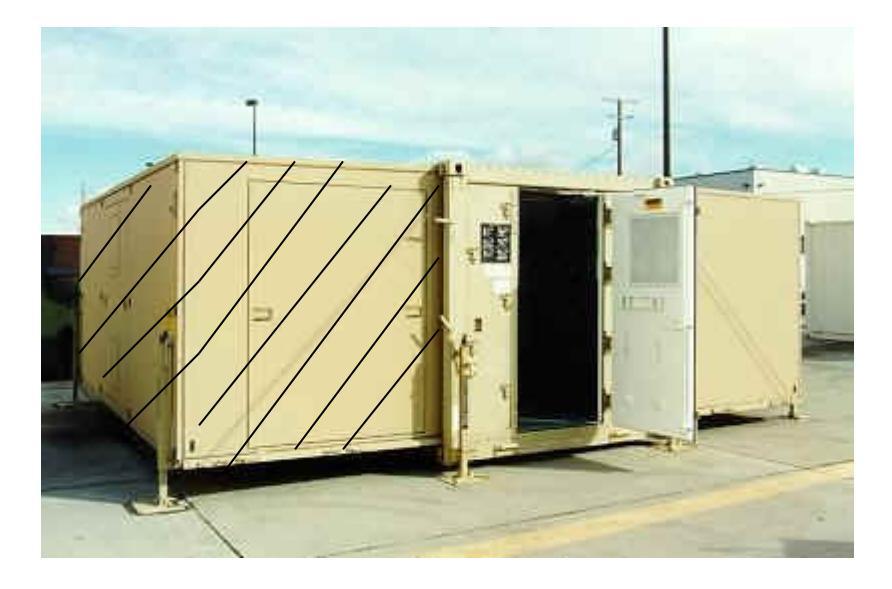
Figure 8. (3-to-1 Shelter for demonstration of appliqué technology). Black cross lines indicate where appliqué was to be installed including the back of shelter and roof over the 3 side panels.

Figure 8 illustrates the 3-to-1 Shelter that was chosen for this demonstration. The black cross hatch lines indicate the area of the shelter that will be used to demonstrate the appliqué technology. In addition, the back side and top of the cross-hatched section of the shelter will also be coated.

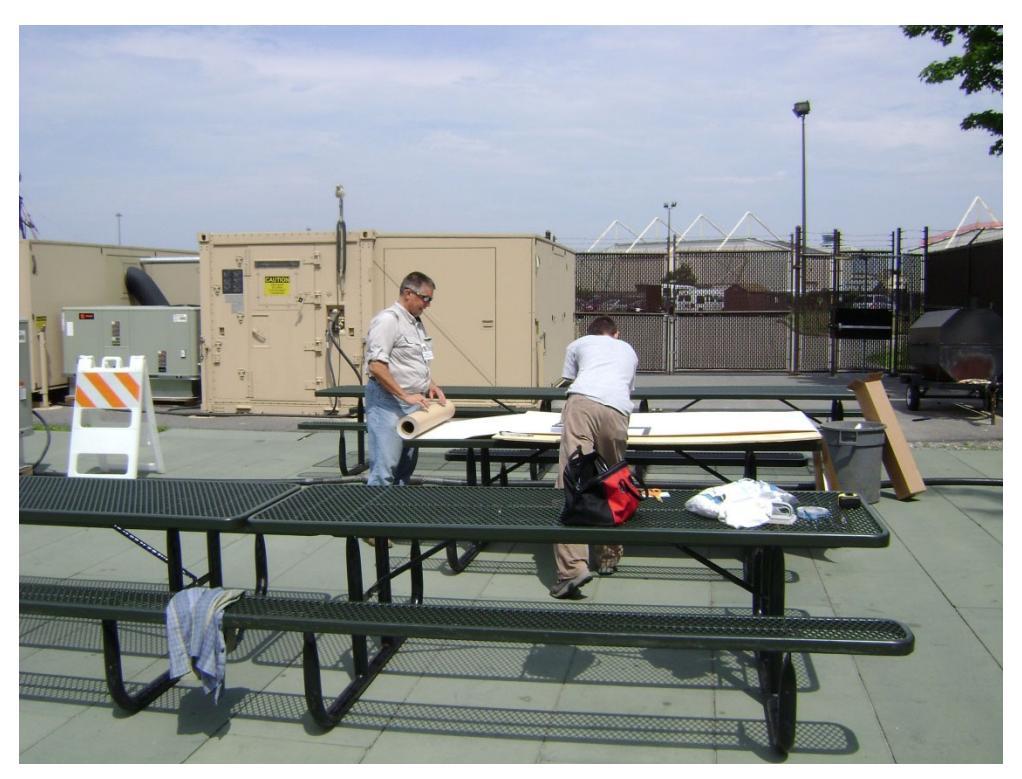
Figure 9. Appliqué set up operation.

Figure 9 shows the setup of the operation and illustrates the ease of installation: Specifically, appliqué technology allows one to coat existing structures, vehicles and equipment or prefabricated sheets with a CARC compliant material that is nontoxic, contains no HAP or VOC's and requires no HAZMAT support during the coating operation.

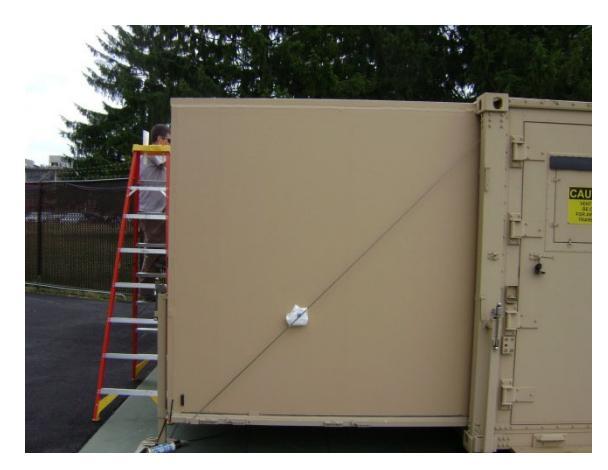
Figure 12. Front panel of shelter - appliqué installation of front panel complete.

There are three sections of appliqué making up this installation. The seams are not visible.

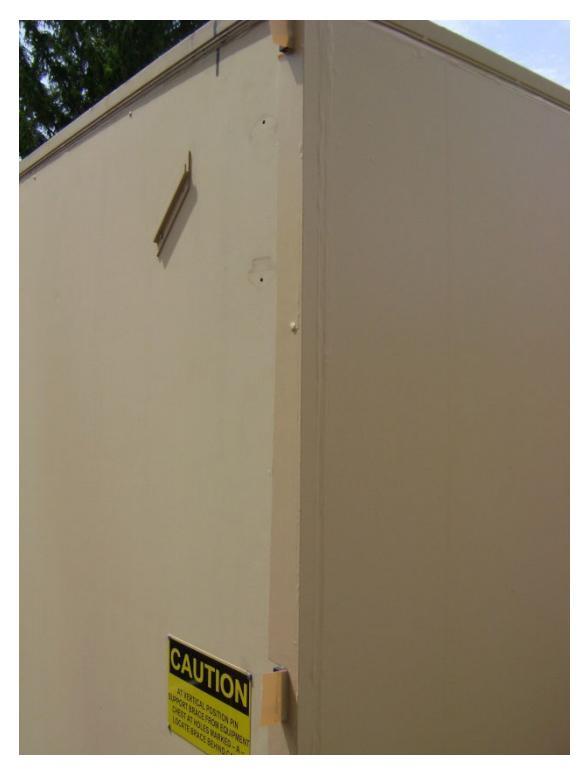
Figure 13. Installation of Corner Section of Appliqué

In Figure 13 one can see the cutouts around non-removeable hardware as we moved from the front panel to the side panel.

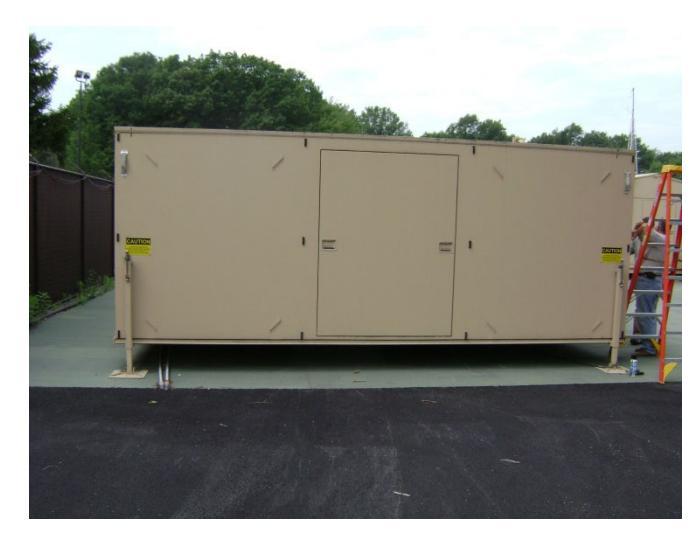
Figure 14. Side of shelter, before appliqué.

Some of the attached hardware on the this side of the shelter was removed before appliqué installation.

Note that right above shelter support leg the Caution Sign is coated over with Appliqué (See Figure 14).

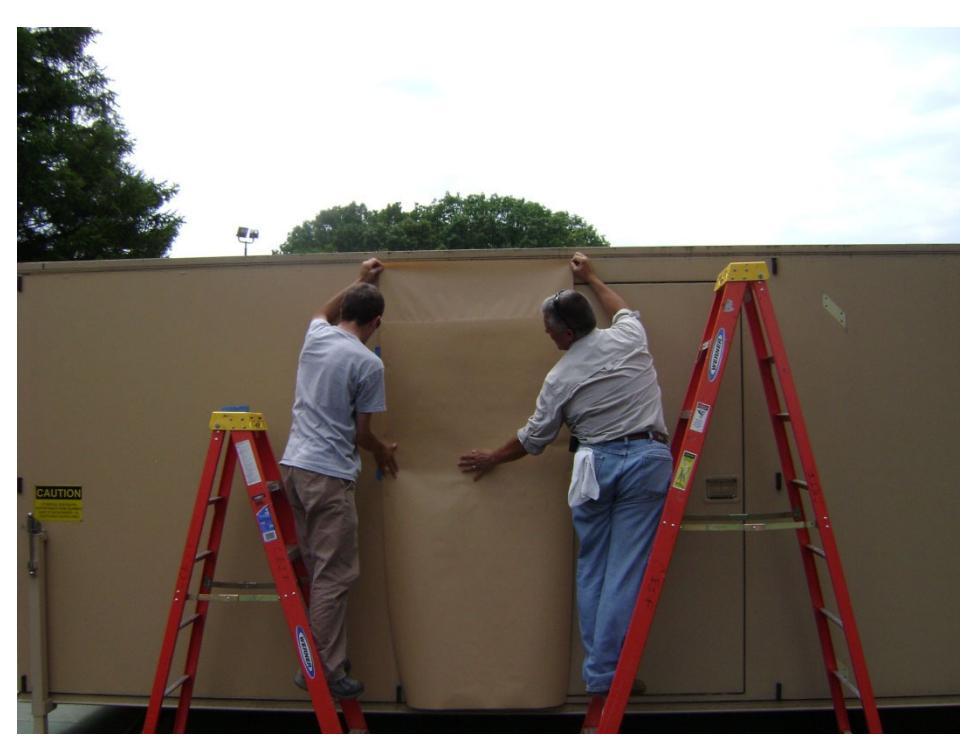
Figure 17. Installation of Appliqué over Door on Side Panel of Shelter

Note that the left side of this panel (Figure 17) is complete and that the Caution Sign on the left side of the side panel is clean. (Compare to Figure 1.16 that showed that the appliqué film was originally coated over the Caution Sign and then removed after finishing that section)

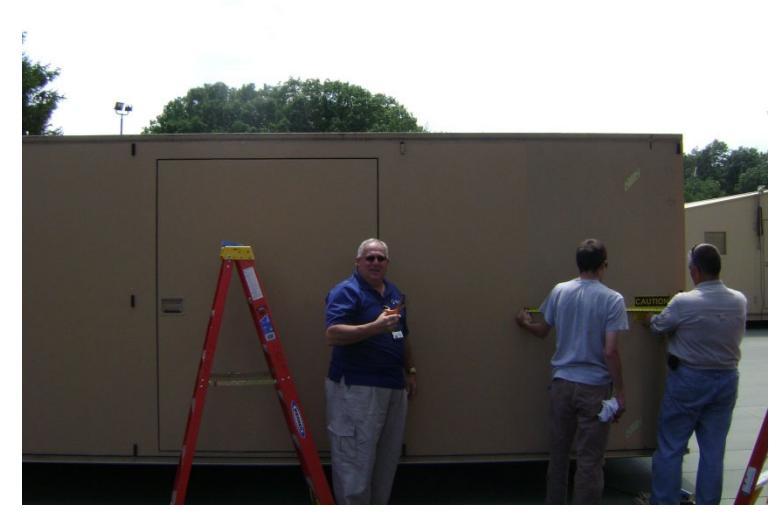
Figure 19. Finishing Final Section of Shelter Side Panel

In Figure 19 the whole panel is almost complete, (including door where one can see that the handle has been effectively trimmed around) excepting about a 3 foot side section being measured.

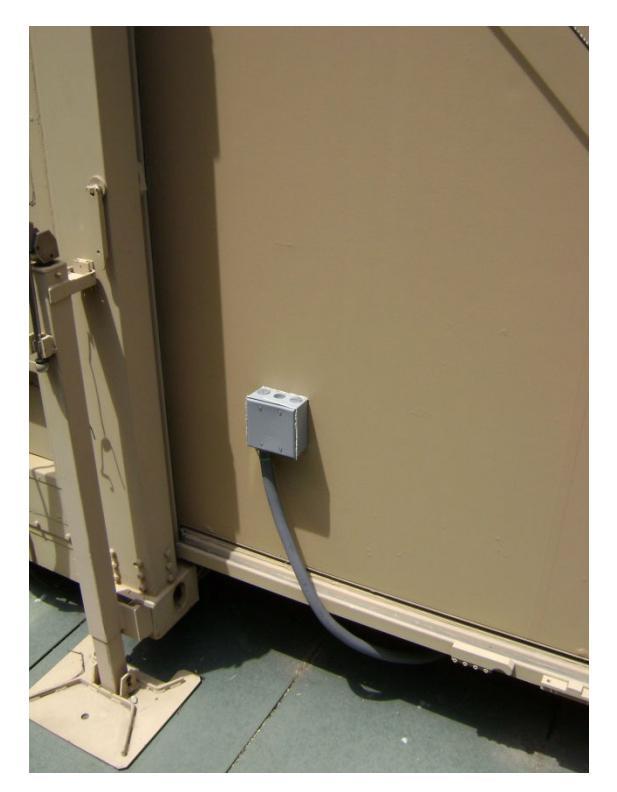
*Figure 21. Appliqué applied under and around power cable on back side panel of shelter.*

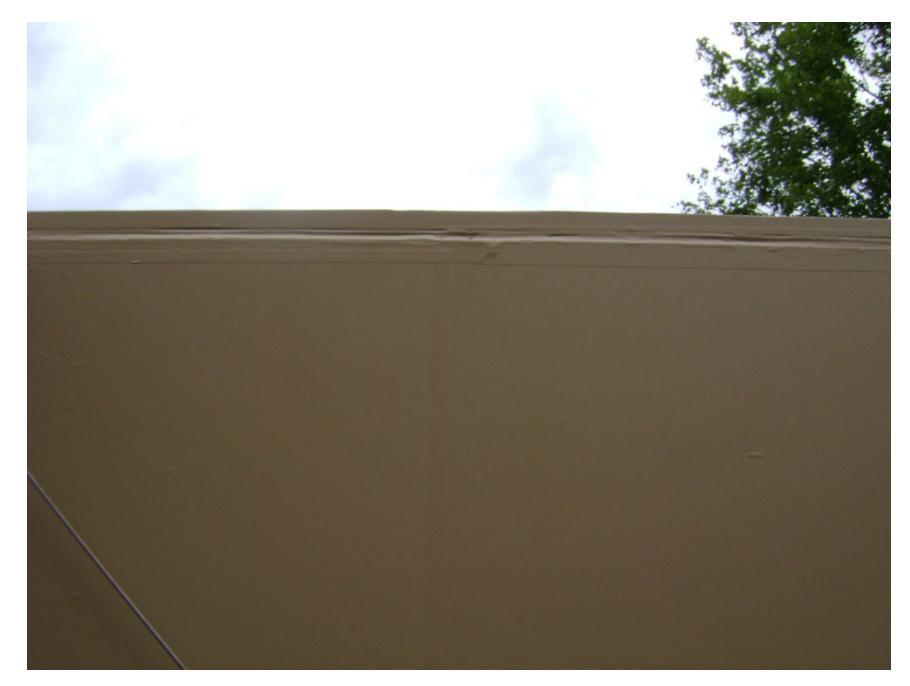
Figure 24. Cap Stripping and Connecting Top of Shelter Roof to Back Side Panel

6" Appliqué tapes were used to cap and connect the roof of the shelter with all of the side panels (This illustrates appliqué on back side panel shown in Figure 1.20). Full coverage of roof was then applied so that no ingress areas from roof to side panels were left. Note again that the seams are very difficult to see. Compare the edge in this Figure to that in Figure 20.
